# 2006 SPITWATER SW201 PRESSURE CLEANER LIFESPAN PROLONGED THROUGH REGULAR SERVICING & REPAIR!

## PROBLEM FACED

SPITWATER SW201

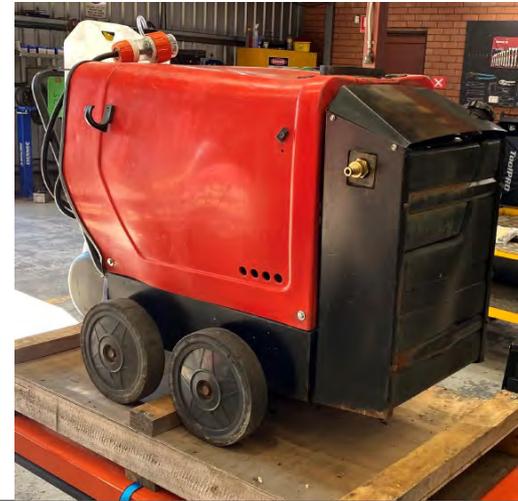
A 2006 SPITWATER SW201 was scheduled in for a service and repair as it had stopped operating. The machine was inspected and it was identified that it had a worn water seals & valves in the pump, a worn bypass, a dirty diesel filter, a worn burner joint, and a dirty water filter.

- 1x Water Filter,
- 1x Float Valve,
- 1x Chemjet,
- 1x Diesel Filter,
- 1x Bypass,
- 1x Safety Valve,
- 1x Pump Seals & Valves;
- 1x Burner Joint.

Based on the fair condition of the machine, it was determined that repairing the equipment was a more viable option than purchasing a replacement pressure cleaner. The client decided to go ahead with the quoted repair work to extend the lifespan of the machine further. Our service technician fitted various replacement parts to the 16-year-old SPITWATER SW201 in the scheduled job timeframe. The regular servicing of this machine and the exceptional quality of the SPITWATER Pressure Cleaner has attributed to its long life and should see a few more years yet.
